# Empower Oarlock

## Troubleshooting the Pin Calibration Process

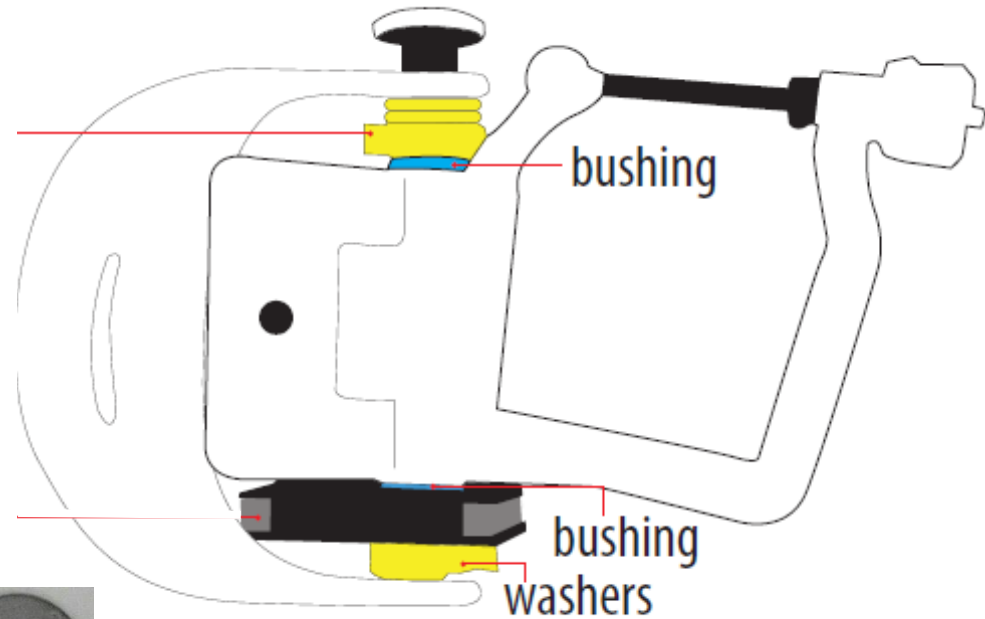
### Issue 3: Overtightening the pin to the oarlock.

You do not want to overtighten the screw at the top of the pin so that the screw is pressing down on the washers and essentially squeezing the oarlock.

Otherwise the oarlock will have some resistance when swinging back and forth and ultimately you will not be able to get a “smooth” swing which will fail calibration.

It is suggested to leave a little room at the top.

The oarlock will still remain in place and be accurate without overtightening it on the pin.

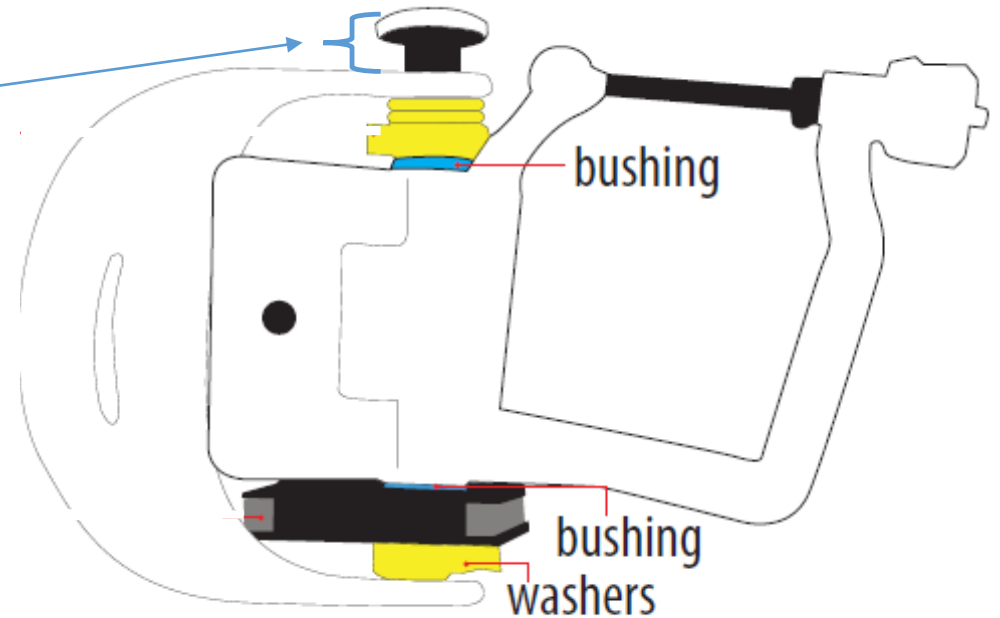
## Issue 4: Using the proper swing speed and technique for Pin Calibration.

Essentially you will need to perform 8 “valid” swings of the oarlock in 1 minute or the calibration will fail. A valid swing consists of going past 90 degrees on both sides of the magnet, without any pauses or stops in the swing at the proper speed. Proper speed is defined a swing every 2 seconds.

If you find that you are having issues getting it to calibrate, it is suggested to slow down the speed of the swing to 2.5 seconds (possibly 3) to see if that helps. Going faster than 2 seconds typically will not work.
