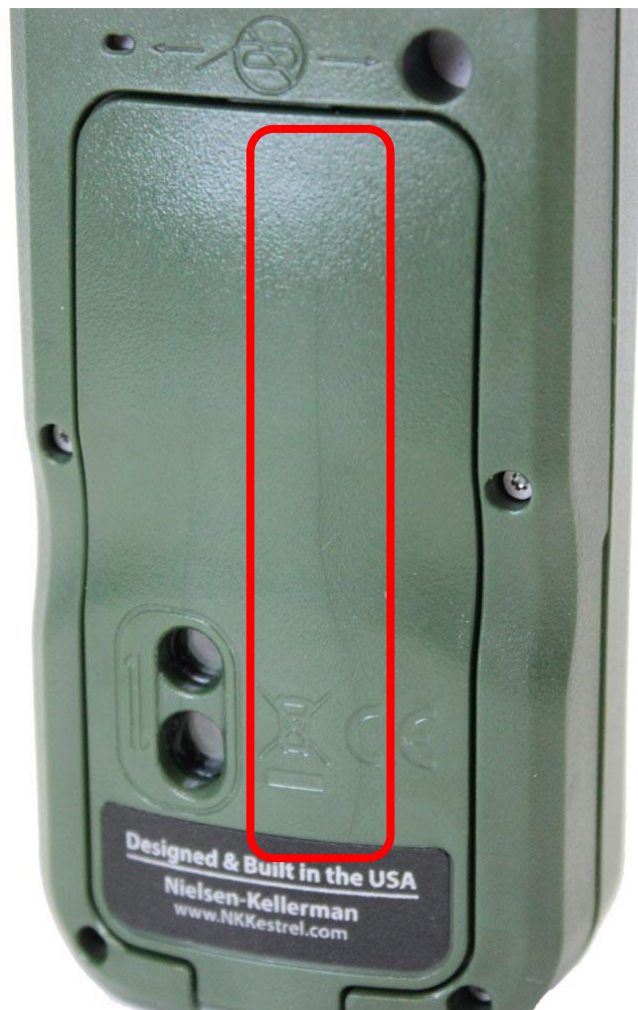
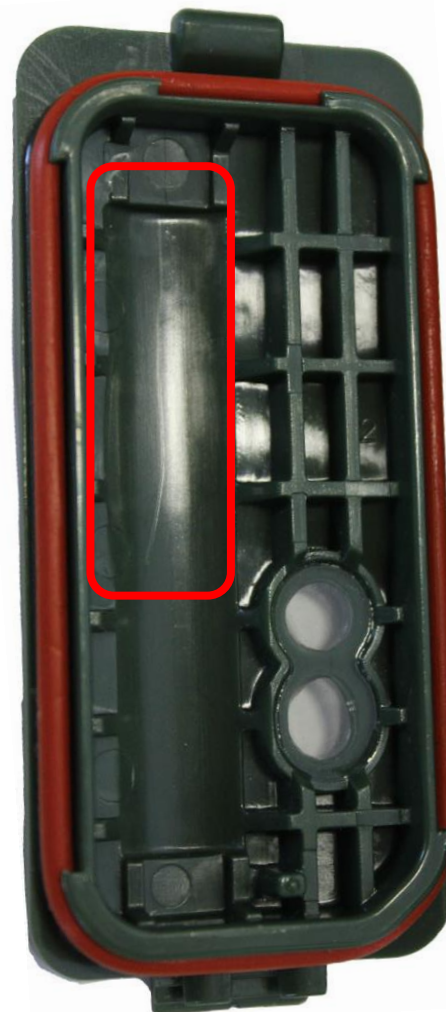
These lines are not cracks or defects. They are called “knitlines” and are formed from the injection molding process to color the plastics. All our Kestrel units will contain these lines and the units are leak tested prior to leaving the factory, so they will not compromise the unit in any way. We have never had a single issue because of these marks so rest assured, your Kestrel will perform at a very high level for a very long time.
