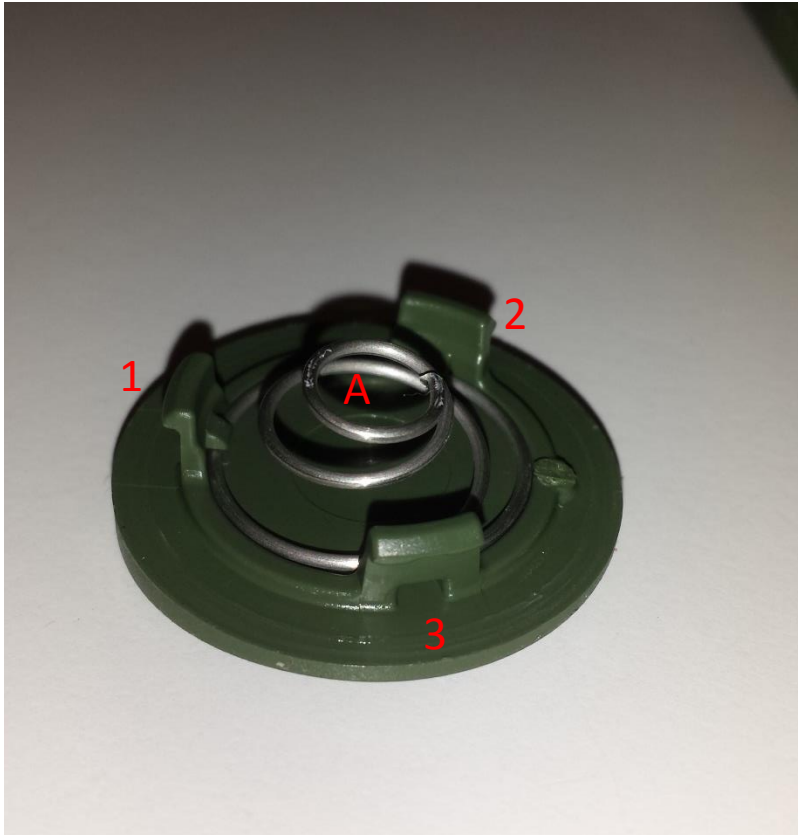
The other area where you can have a power issue is with the battery door itself.

First check all three plastic posts to see if they are still intact (1,2,3). If any are broken or misshaped, we can send a replacement battery door.

Next you want to check the spring (A) in the center. It should extend past the 3 posts (at least enough past the posts that it's obvious) and have some "springiness" to it. This spring can become degraded over time and cause power issues. Again please contact us for a replacement battery door.
