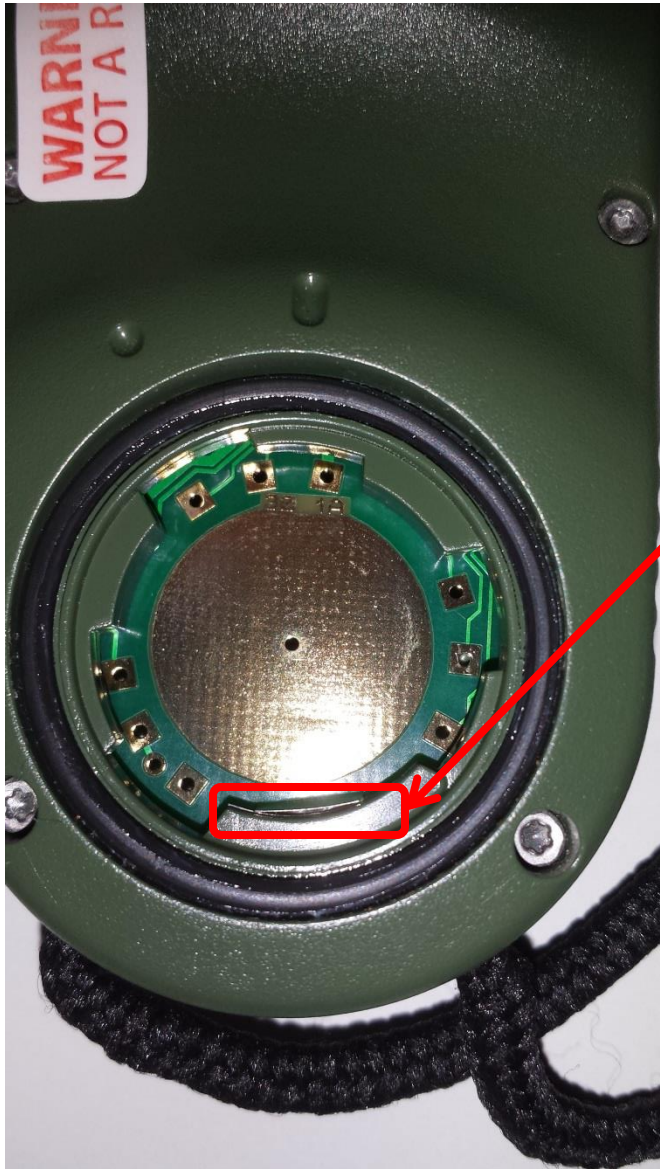
Look for the Battery Clip located in the 6 o'clock position. This clip is a silver sheet that should be perpendicular to the bottom, highlighted in RED in the picture to the left. Please check to make sure this isn't bent. If so, gently nudge it back against the plastic post.

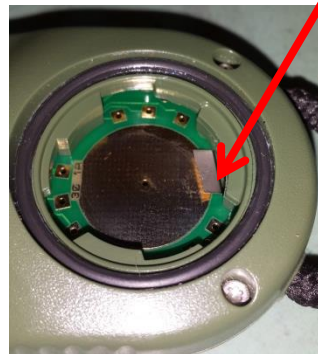
Side View

These are examples of bad battery clips. Notice the clip is bent forward. You will want to nudge these to make like one shown on left.

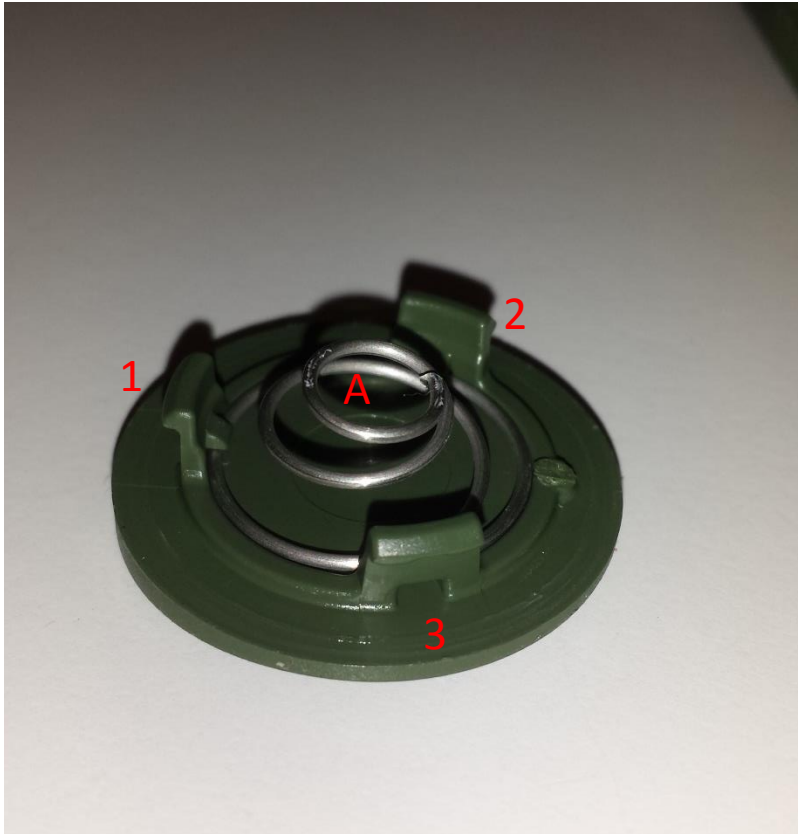
The other area where you can have a power issue is with the battery door itself.

First check all three plastic posts to see if they are still intact (1,2,3). If any are broken or misshaped, we can send a replacement battery door.

Next you want to check the spring (A) in the center. It should extend past the 3 posts (at least enough past the posts that it's obvious) and have some "springiness" to it. This spring can become degraded over time and cause power issues. Again please contact us for a replacement battery door.
